# Damaging Effects of July 26, 1963 Skopje Earthquake

Jakim T. Petrovski

*Institute of Earthquake Engineering and Engineering Seismology,  
University "Cyril and Methodius", Skopje, Republic of Macedonia*

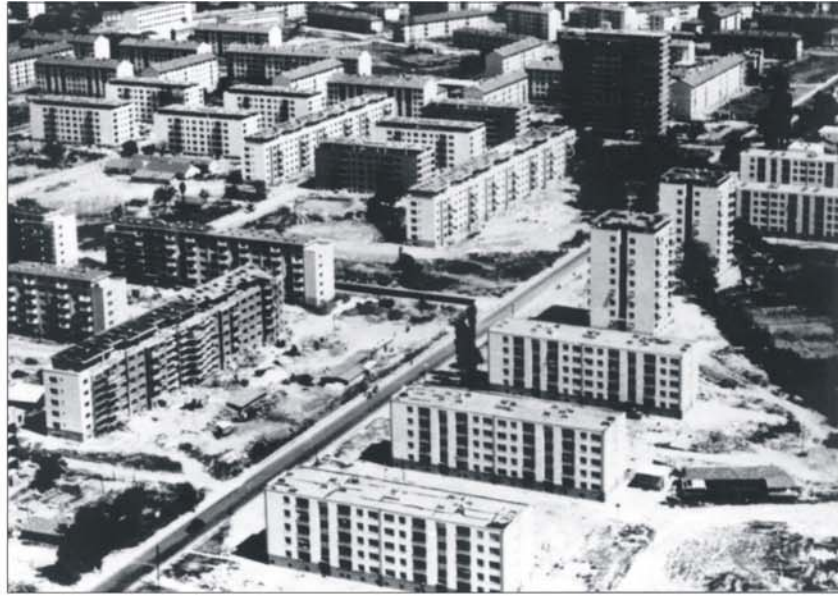
**Fig. 2.** General view to the five storey masonry buildings in the West Side of the city of Skopje, before earthquake

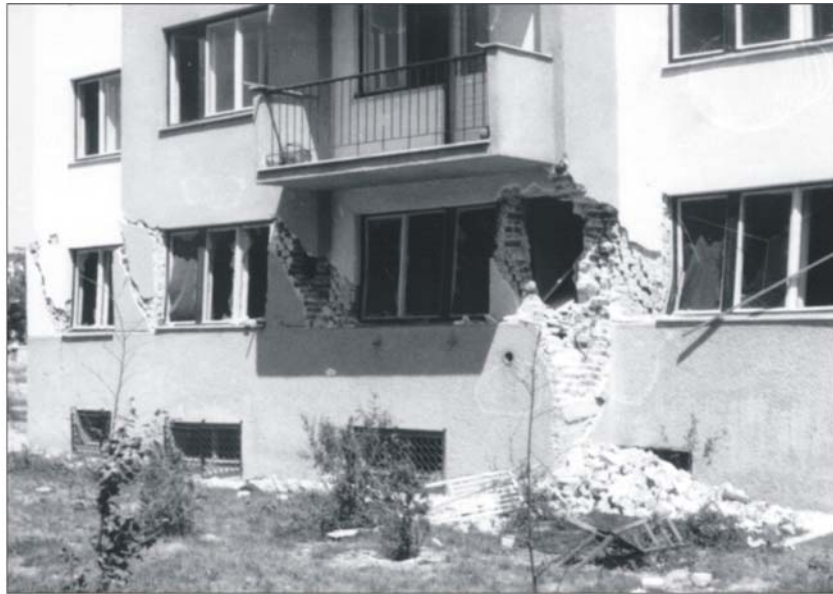
**Fig. 4.** Damage pattern of five storey masonry buildings of Type B

Generally speaking, the brick masonry wall structures of buildings suffered more than any other type and accounted for the larger number of deaths. Mixed construction also suffered considerably. Although many of these buildings did not collapse they were left completely shattered, beyond repair. Old adobe structures, particularly those with timber bracing, resisted the shock with some damage but behaved far better than the brick masonry or the mixed structures. Reinforced concrete skeleton structures suffered comparatively little damage and only two small structures of this type collapsed. Tall skeleton structures, up to 15 storeys, performed far better due to the specific frequency content of the earthquake. They were constructed with more care and, in some cases, wind forces were considered in the design. Finally, prestressed structures were totally destroyed after the collapse of their supporting columns.

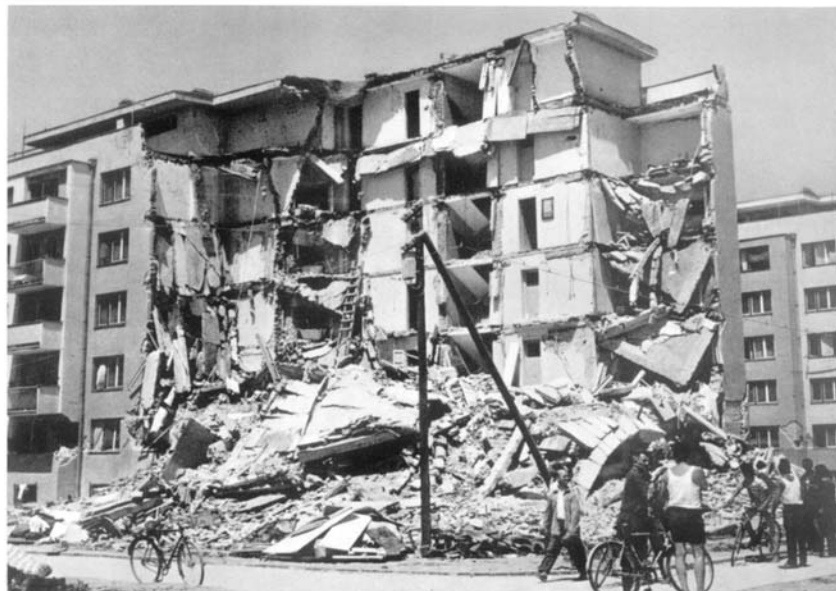
**Fig. 5.** Failure of right side structural unit of five story apartment masonry building in the West side

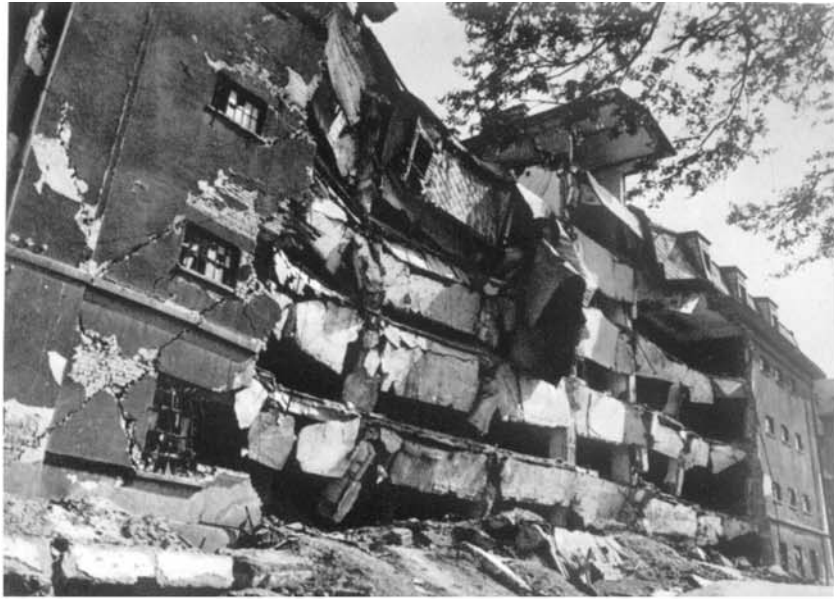
**Fig. 6.** Pancake failure of tobacco factory masonry building in central part of Skopje

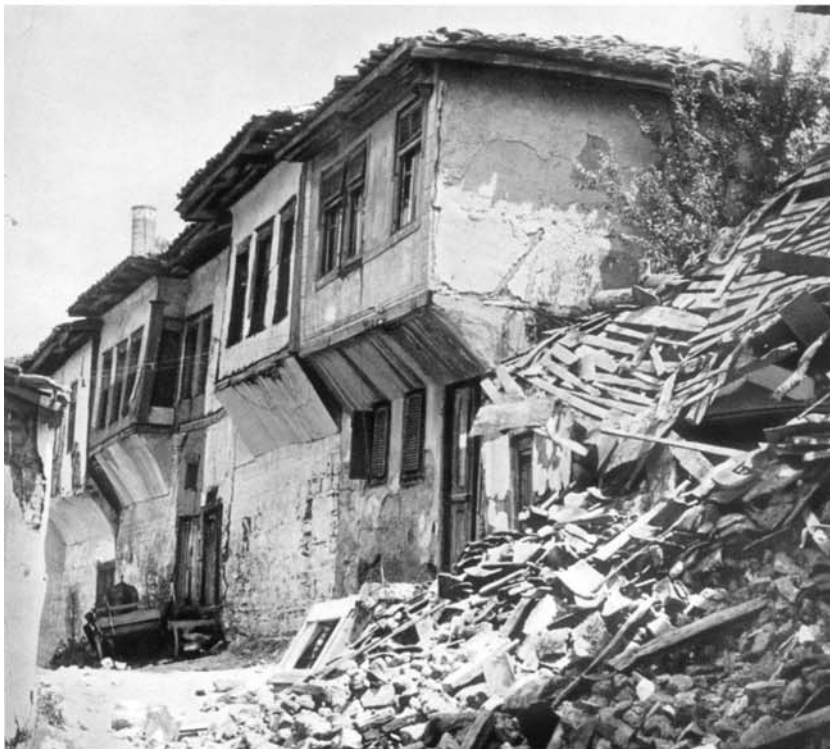
**Fig. 7.** Slight damage of wood-framed Macedonian dwelling (left) and failure of rubble stone masonry dwelling (right) in the central part of Skopje

Due to implemented development of the city of Skopje as administrative and industrial center of the Republic of Macedonia after 1950, rapid physical growth of population required construction of the large number of apartment buildings, which were mainly concentrated in the West Side of the city. More than 3,000 apartment units have been constructed in the period of 3 - 5 years, mostly as five storey masonry buildings of typified construction in rather low to moderate quality of construction works. Most of these buildings in the new West Side residential area were heavily damaged during July 26, 1963 Skopje Earthquake as presented in Figures 2, 3, 4 and 5. Dramatic failures have been observed in the Central part of the city (Fig. 6) as well as old part of the city with favourable behaviour of wood-frame dwellings (Fig. 7).
