The Dead Sea Earthquake mb 5.1 of February 11, 2004
A Preliminary Report

*Dr.Eng. Jalal Al-Dabbeek, ESSEC Director ;Dr. Radwan Al-kelani ;
Arch. Mohammad Dwaikat and Eng. Aya Arafat*

**An-Najah National University
Earth Sciences and Seismic Engineering Center (ESSEC),
Nablus, P.O. Box 707, Palestine**

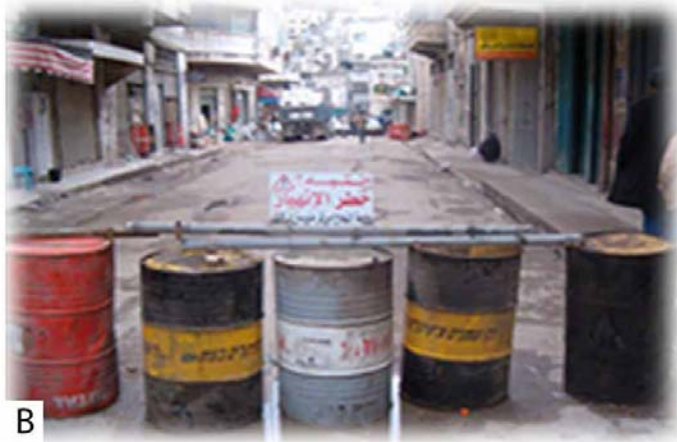
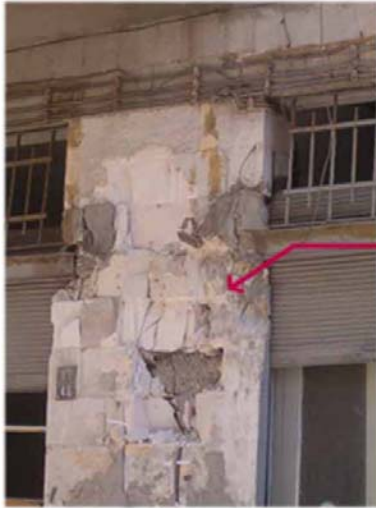
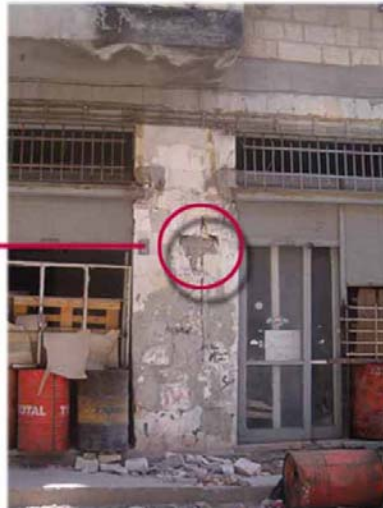
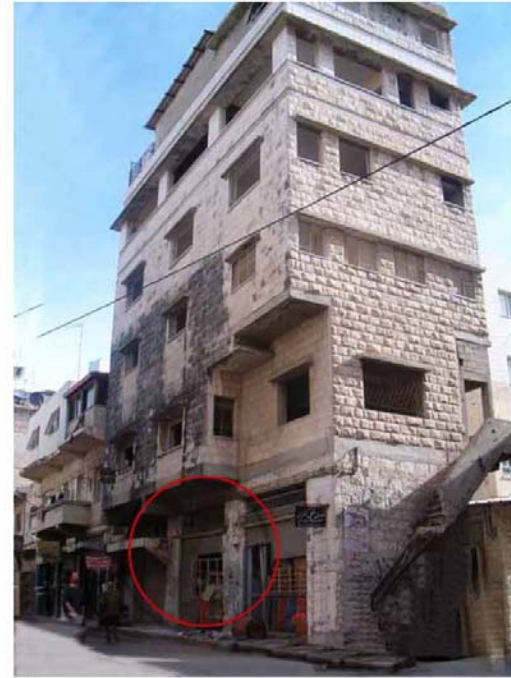
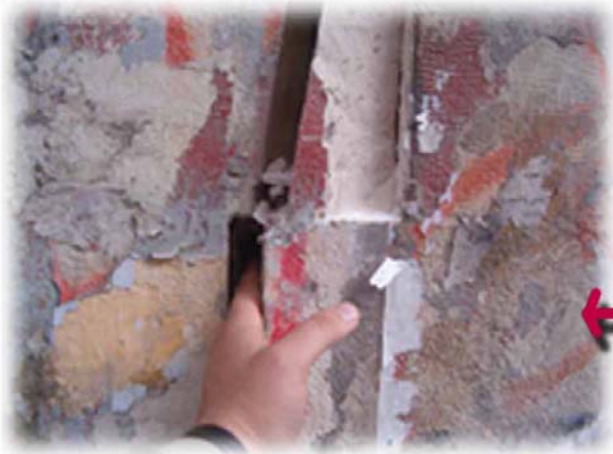
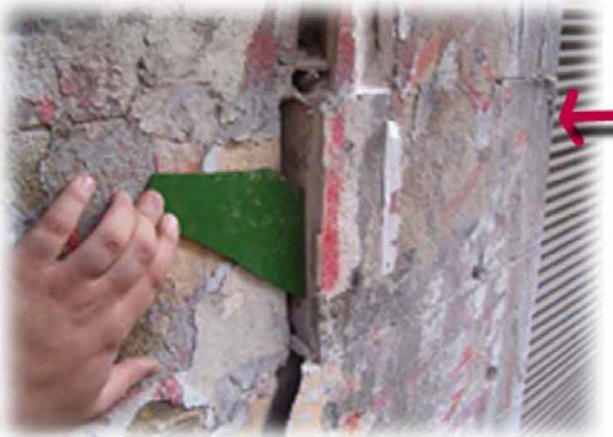
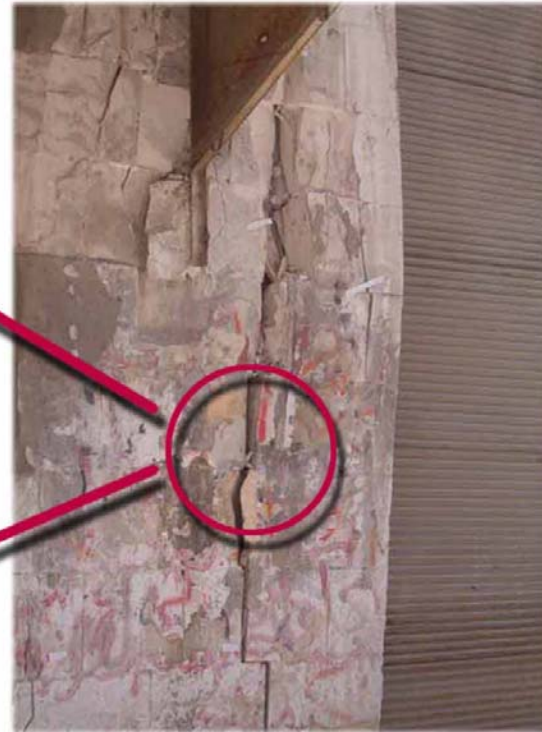
fig. 1
Crack Patterns, Crushing
and Large permanent
deformation in the
Masonry Pillars.
see more details page no. (4/8)
page 3/ 8

Five Storey Masonry Building- NABLUS City

B
Expulsion of blocks in poor mortar stone

Five Storey Masonary Building
NABLUS City

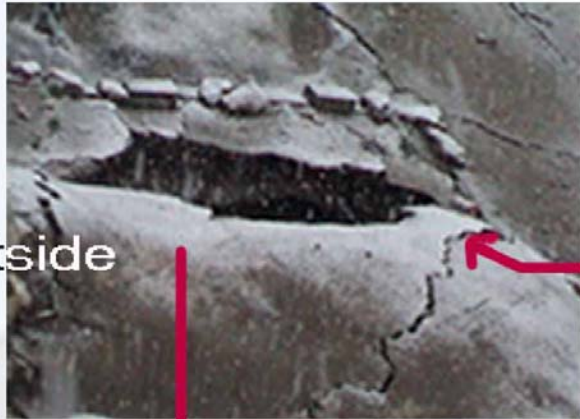
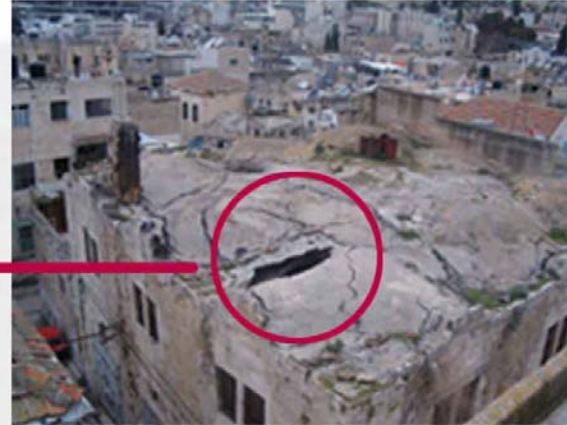
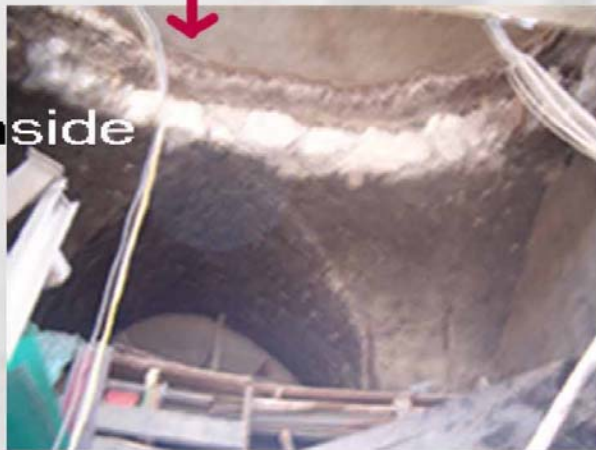
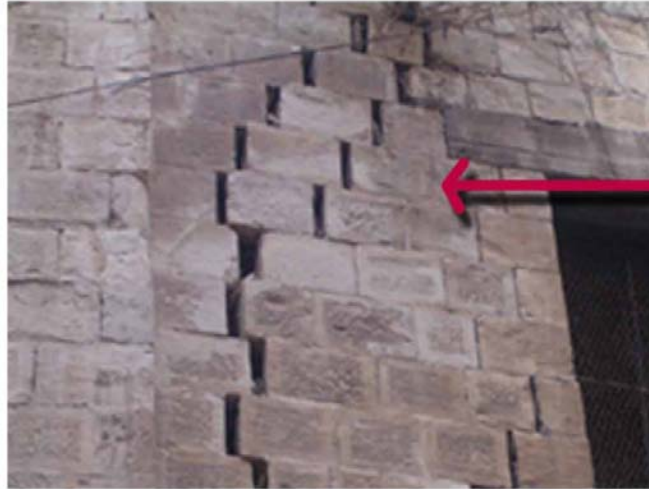
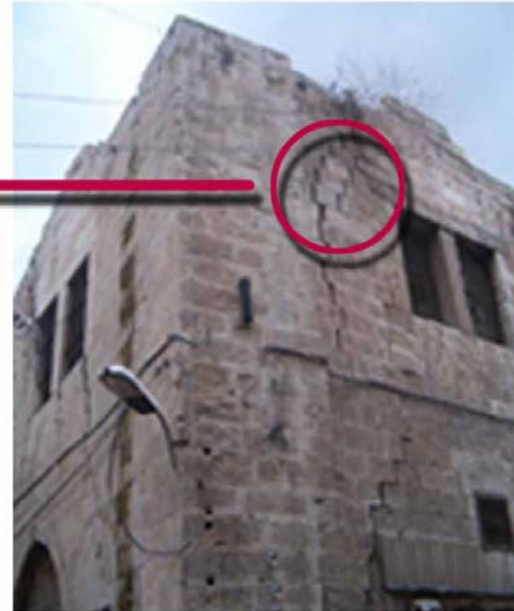
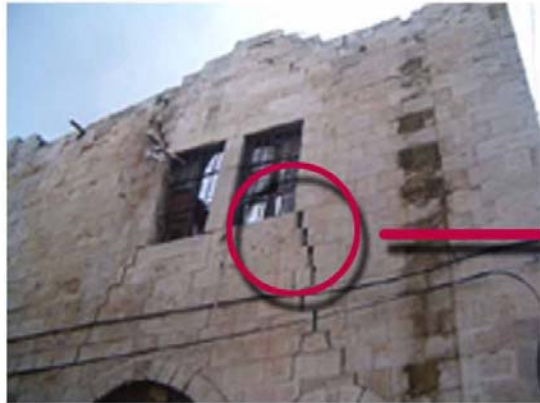
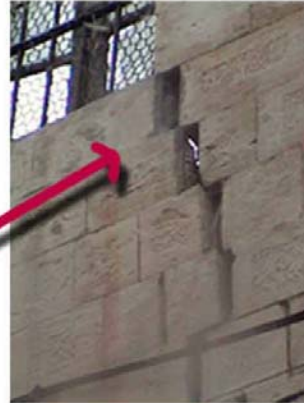
fig. 2

A flat vault's collapse

Old Masonry Building

Location: Old town of NABLUS city

Structural System: Cross Vault's

Use: Soap Factory

Corner Detachment of Building

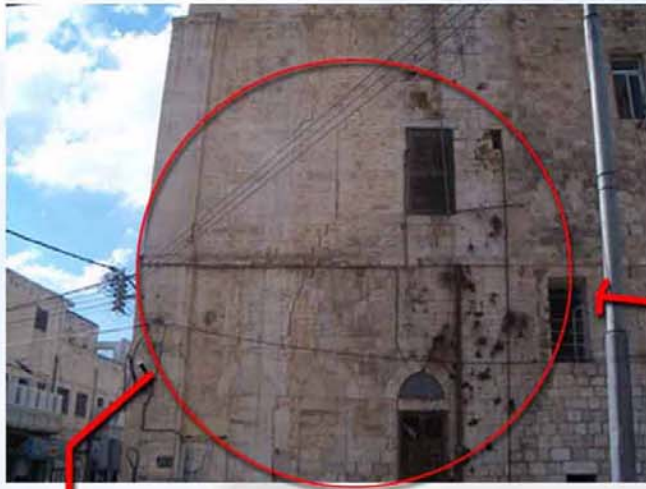
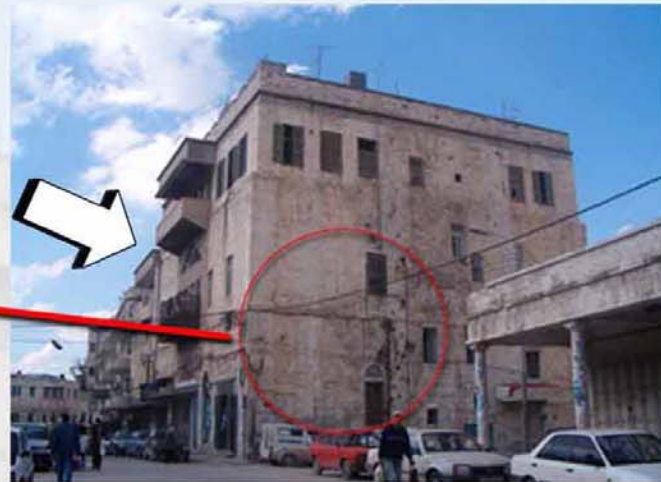
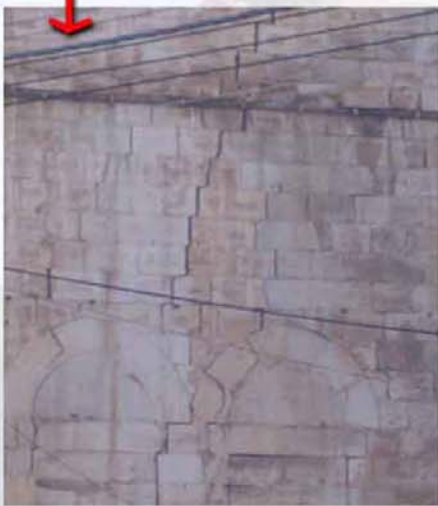
fig.3
Old Masonry
Building
NABLUS City

Crack patterns
